Manhole Inspection Summary

Manhole # S33C__042MH

Insp Date: 7/31/08 2:28 PM

Location Address: **19 cathedral st**

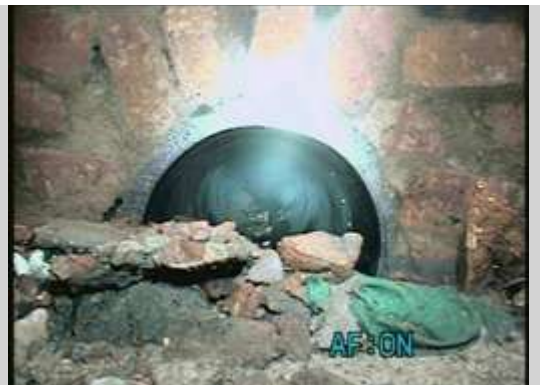
12 O'Clock Outflow

8 in. Circular Gravity Sewer
Pipe Out @ 12 O'Clock

Infiltration: **None** Pipe Seal Cond: **Unknown**
